INS11842B - 1/13

Safety Grab Bar

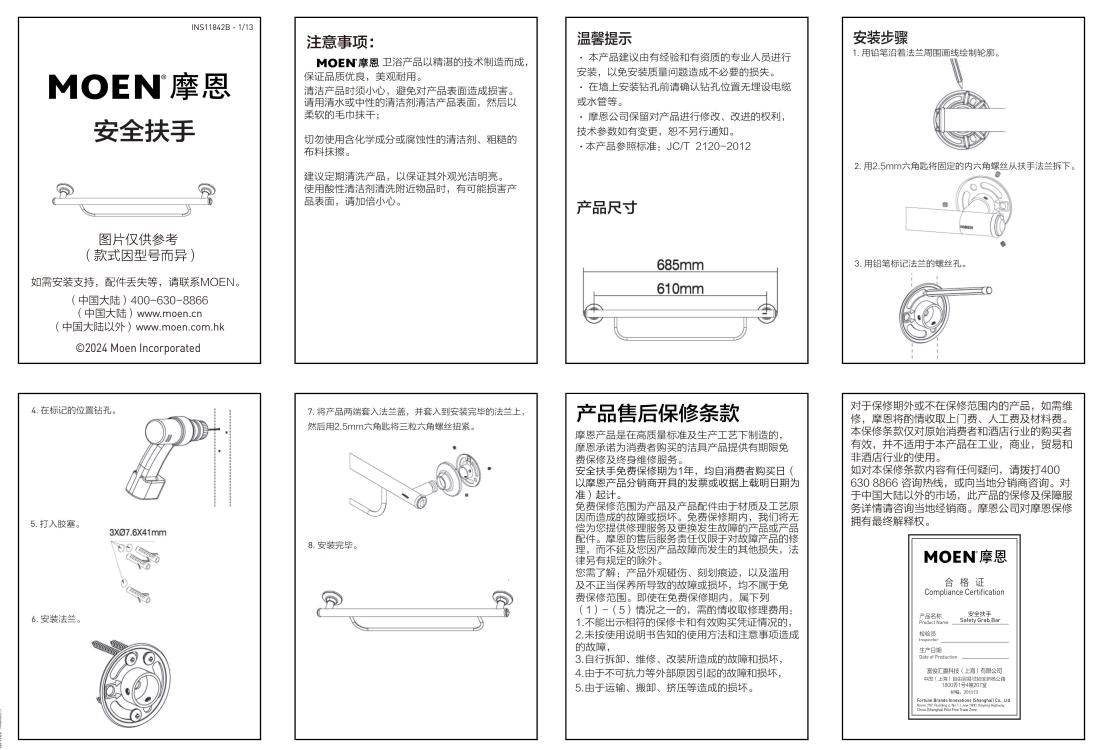
Image is for reference only (Style varies by model)
